HYDROLOGY

HYDROLOGY STUDY

The following chapter considers the hydrology of Abbey Fields. It is a study and not a detailed hydrology survey but provides an overview of the hydrology of the Fields, its constraints and opportunities. A field survey along with EA flood data and historical hydrological events have informed the study. It is advised to undertake a detailed hydrological survey to determine further opportunities within the Fields.

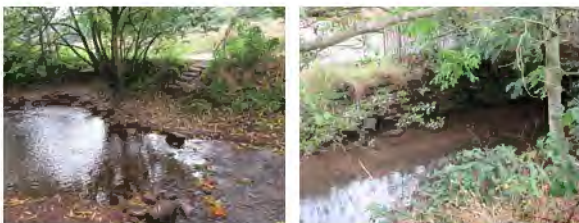
Finham Brook is set within a deep, wide channel that towards the Leisure Centre has steep walled embankments associated with the two bridges and what appears to be the

infrastructure of an historic mill. The base of Finham Brook is gravel and pebbles. It is heavily vegetated, but its width provides a sense of openness to the brook, with gaps

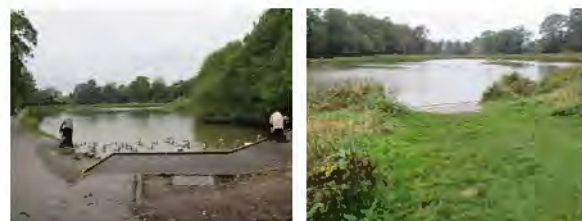
Abbey Fields Lake is located to the north of Finham Brook, and west of the leisure centre. A more recent 20th Century addition, this covers a large area of land midway up to Castle Road. It is a man-made lake and is controlled by a managed intake and outlet, with any movement of water into and out of the lake agreed with the Environment Agency. Originally the land was managed as a flood water meadow, with dams and a sluice network used to control the water. However, following the development of the leisure centre, the pipework was

unfortunately damaged and the flood meadow ceased to exist resulting in the development of a marshland landscape. However, it was later agreed in 1997 on its formation as a permanent lake feature, and the area was dug and filled with water under control.

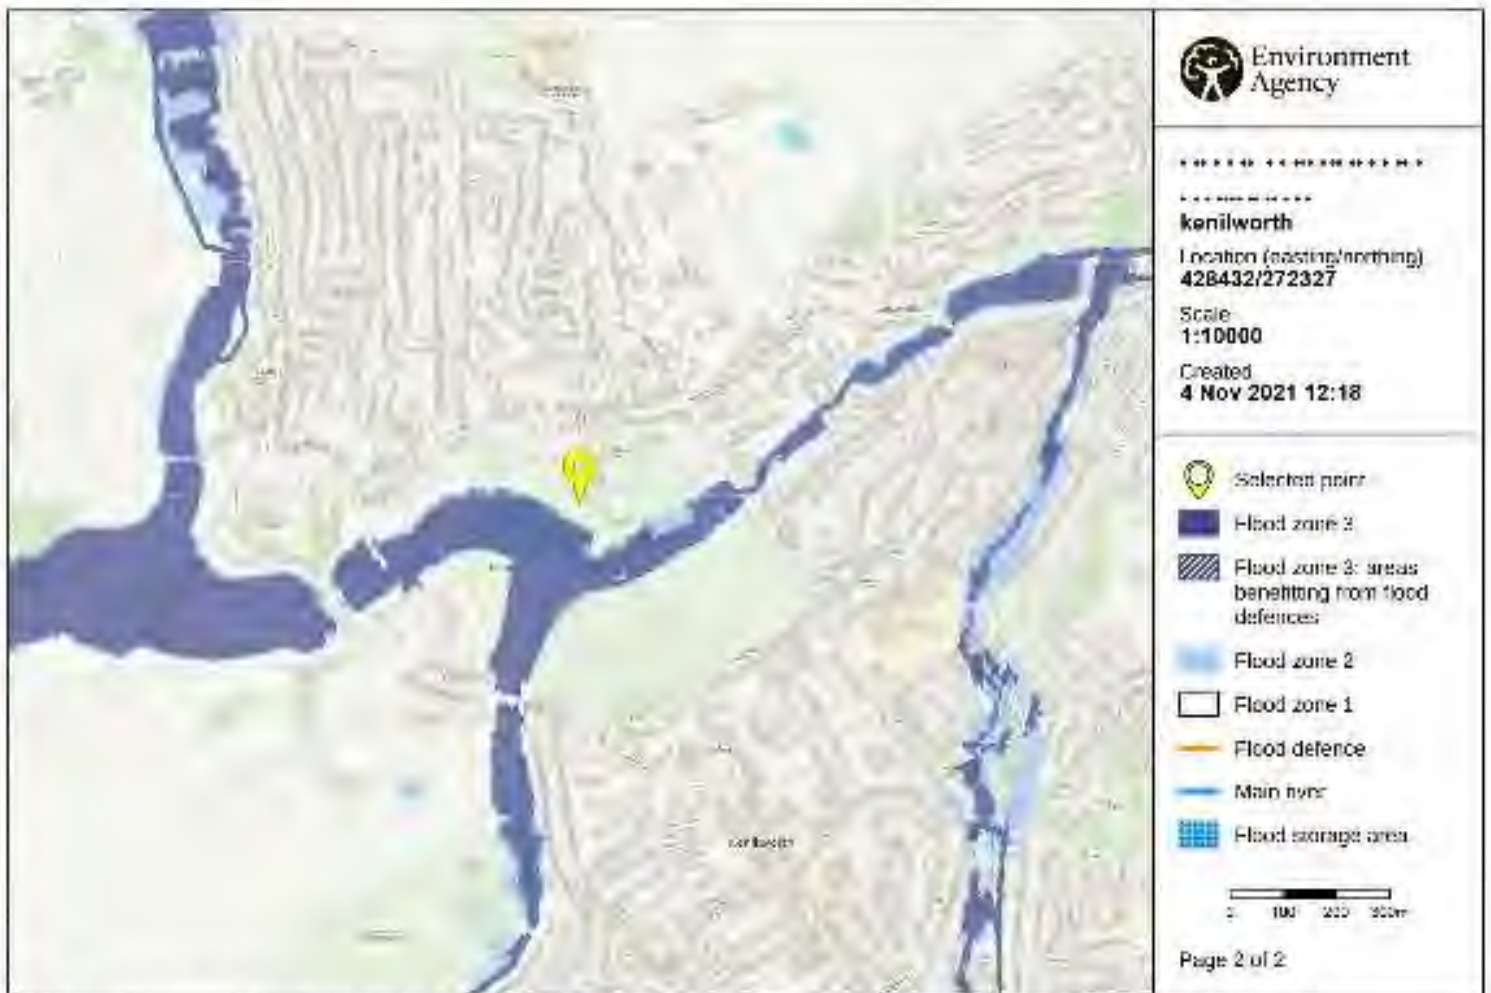
Map 1: Wider Flood Zone Map around Abbey Fields

Both Finham and Luzley Brook flood and the lower reaches of the Fields including the lake are identified as being within flood zone 3. The connection that this has with the wider area can be seen in Map 1. Map 2 identifies the extent of flood zone 3 around Lakeside and South Brook zones. Whilst Map 3 shows that there are minimal areas of flood zone 2 within Abbey Fields, generally identified within the tennis courts. The land rises steeply either side of flood zone 3 preventing the possibility of increasing capacity within the Fields from flood incidence.

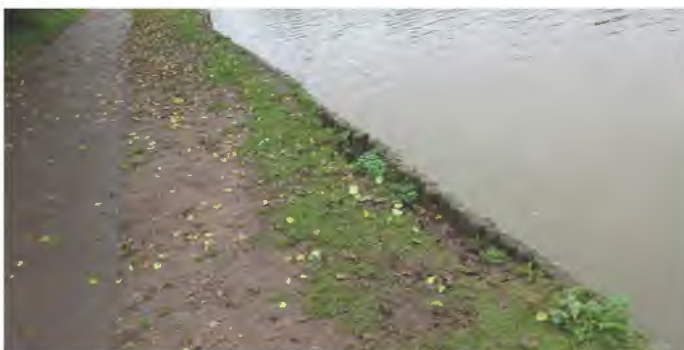
There is also undercutting of the footpath margins towards the south east of the lake. It appears that the log roll edging has rotted and water is undercutting the bank. This is not helped by the volume of footfall in this location when feeding the ducks.

5. **Consider removing the timber edging to the beach location and create a gentle sloped beach into the lake to allow for a more positive interaction with the lake at this location. Retain all vegetation to the sides of the beach area.**
6. **Investigate the extent of undercutting and replace the log wrap with suitable alternative that also acts as an extended platform for feeding the ducks. This may require a solid platform that would need further consultation with the Environment Agency.**
7. **Obtain accurate service records for locations of services within Abbey Fields for future management of the Fields.**
8. **Consider the possibility of utilizing rainwater from the proposed leisure facility to feed into the lake.**

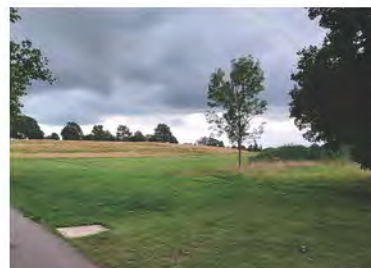
Water was originally running over the path and the area was dug a number of years ago to investigate the cause of the water issue. It was believed to be historic and potentially associated with the former Mill and was subsequently closed without repair. An Historic England approval was granted for the drainage of this location. This included a pipe under the path to a sump with a French drain leading from this location into the wetter area. However, only the pipe under the path was constructed with a temporary cover placed over the incomplete sump. The sump and the French Drain has yet to be completed and installed, with the temporary cover still in position.

2. **Complete the outstanding drainage work approved by Historic England and remove the temporary cover**
3. **Embrace the wet spot and manage the marshland allowing encroachment of vegetation and Phragmites.**
4. **Consider installing further swale drainage from the wet spot to the hedgerow ditch, with pipework under the footpath and series of swales towards Finham Brook, allowing movement of water in a controlled but natural way. This would need further design and approval from Historic England considering the proximity to the former Mill.**

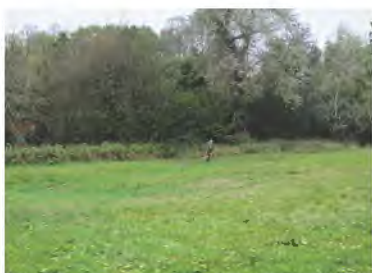
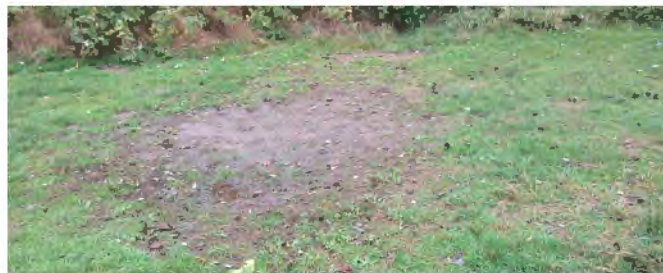
The site visit identified that the ground dips with two small hollows that appear to be a seasonal pond, but during the site visit there was no sign of collecting water. A large crater is located further east of this area and this is advised to be retained

as a feature and not incorporated into this wetland area.

At the time of study this area was dry and the meadow area cut and land maintained. Adjacent to this area nearer to Finham Brook, water collects and puddles creating muddy areas that are regularly walked through. Avoidance of these areas creates a wider erosion problem. This area has been identified within the Ecological assessment as having potential for the creation of small ponds subject to approval.

1. **Consider creation of a wetland area and allow wetland species to flourish. Refer to the ecology section for recommendations.**
2. **Provide an informal drainage channel from the muddy area into the pond adjacent to create a dryer area for pedestrians and encourage water into the pond.**

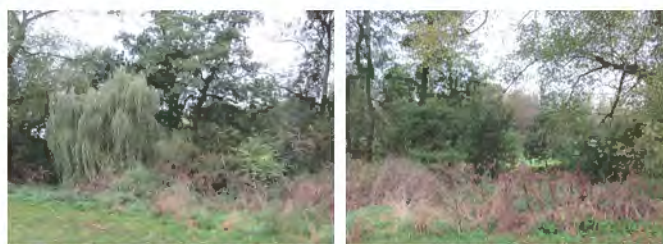
Finham Brook margins

Further east on Hillside between two mature trees along the vegetated bank of Finham Brook the ground is wet and boggy and appears to have species suitable to wetter ground.

1. **Potential to broaden the margins of the brook bank to encourage more of the wetland habitat and move the informal path to a dryer location at the base of the Hillside embankment.**

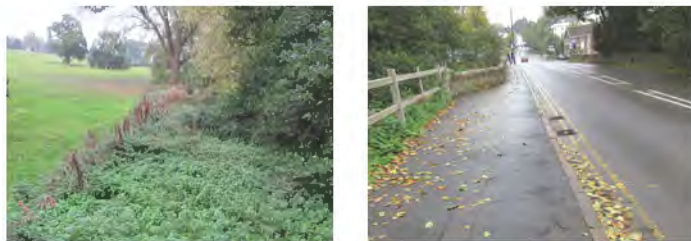
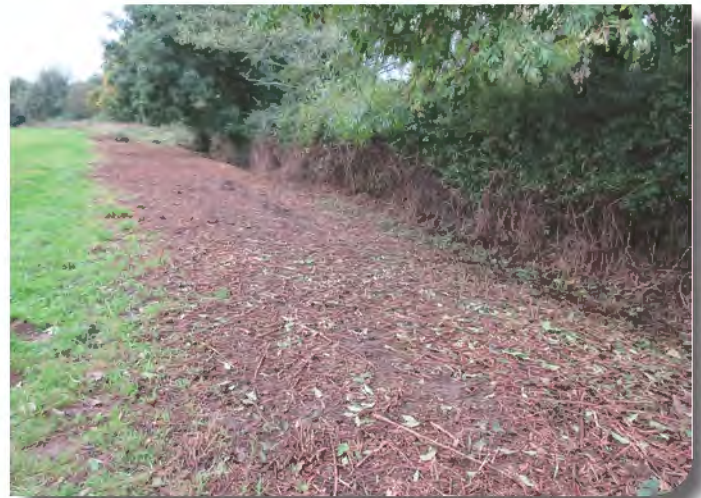
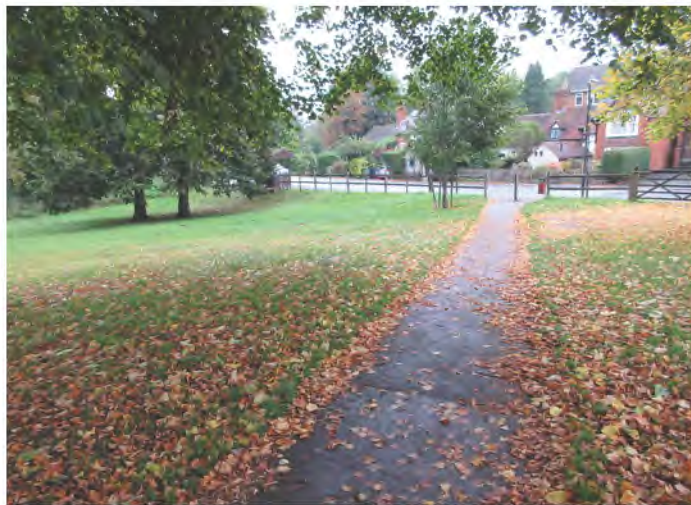
Hedgerow

The existing mature hedgerow to the west of Hillside appears to have a ditch network associated with the hedgerow. Where recent clearance work has been undertaken this is clearly apparent.

Some of these locations are marshy particularly near to Castle Road at the base of Forrest Road embankment. The vast majority appear dry, although it is difficult to assess considering the extent of bramble vegetation to the boundary of the hedgerow. The meadow landscape on Hillside and the bramble vegetation will slow the flow of water towards the ditch. There is water collection within the hedgerow ditch nearer to the wet area at the base of Hillside at the historic Mill. Due to path infrastructure, movement of water to Finham Brook is impeded.

Monitor the water levels within the ditch to determine whether there is a requirement for provision of pipe network under the footpaths to allow for natural drainage into Finham Brook via a series of swales or additional ditches.

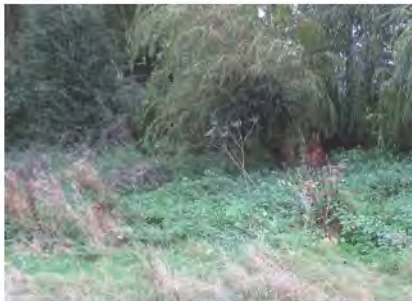
A damp area of tall ruderals is located along the margins of Luzley Brook, near to Borrowwell Lane secondary entrance.

Historical information suggests that this area has been formed as a result of drainage issues from nearby dwellings. It is also possible that there is overspill from Borrowwell Lane during periods of heavy rainfall. Water also collects at the base of the informal secondary entrance. This entire area is generally muddy, soft underfoot and has been known to be difficult to pass as well as causing issues for maintenance machinery.

1. **Consider the process of moving the water away from the base of the entrance area, via a series of swales leading to the existing wet area. The existing wet ground could be broadened and smaller ponds created that allow for ponding and directing water away from more problematic areas. This is subject to permission from Historic England and would require further design and detailed investigation.**
2. **Alternatively should drainage continue to be an issue, French drains could be installed. All works are subject to Historic England approval.**

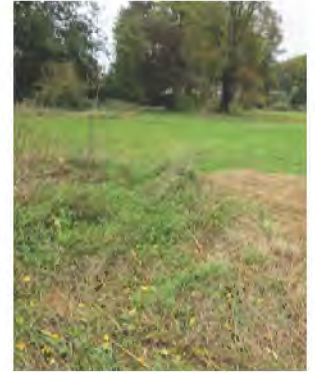
Within the South Brook zone there appear to be a number of historical drainage ditch depressions that traverse the lower fields from the gardens of dwellings from west to east. One of these follows the line of an historic field boundary that no longer exists. The remainder may have been used to drain the land effectively following flooding. Silting and marginal vegetation along the brook has blocked the exit of the ditches into the brook and may cause ponding during seasonally wet periods.

The remainder may have been used to drain the land effectively following flooding. Silting and marginal vegetation along the brook has blocked the exit of the ditches into the brook and may cause ponding during seasonally wet periods.

Should the need arise to drain this area of land, reconnecting the drainage ditches to Luzley Brook would reduce ponding.

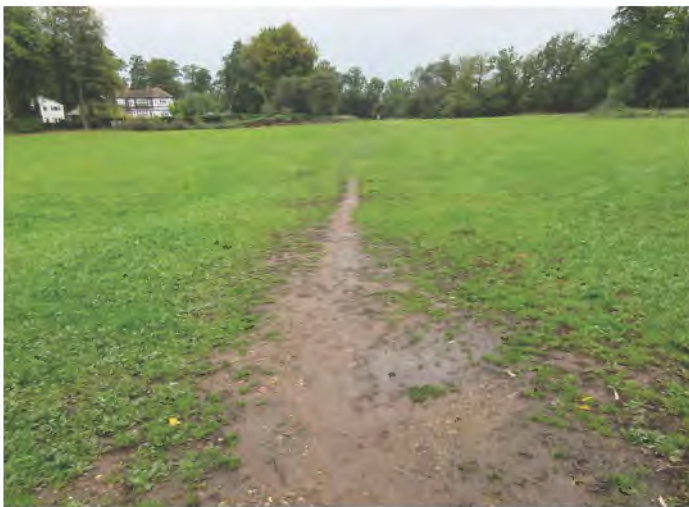
Timber Bridges

The timber bridges that cross the brooks all have water puddling issues in relation to the paths that lead up to the bridges. These are all informal paths and in some instances have been laid to hardcore around the immediate curtilage of the bridges, but the extent of wear extends much further. This is also a problem at the crossing between Hillside and Play & Leisure zone. Erosion management has been undertaken for many years, but the volume of footfall has continued to erode these areas.

Further extending the hardcore or provision of tarmac paths may help to reduce the erosion issue and prevent puddling. The water holding is generally caused by wear of the grass and subsequently mud underneath. Introducing repair work including raising the surface and ensuring there is enough fall to allow for free drainage may reduce this issue over time.

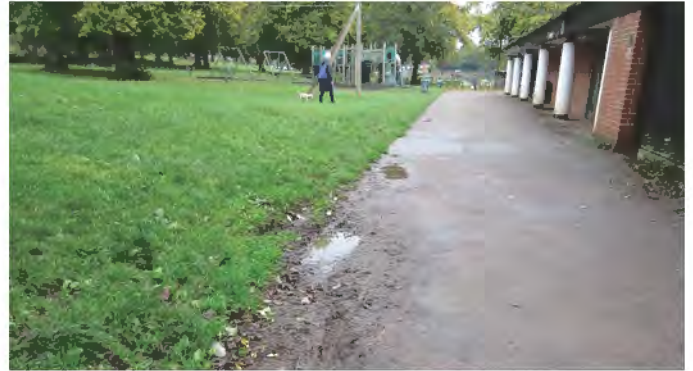
Towards the leisure centre, there are drainage issues in front of the public toilets. The water has created wet and muddy areas that are also apparent during drier weather as the only form of drainage is evaporation. The camber of the footpath is such that the water pools at the base of the grass embankment.

With the Leisure Centre redevelopment there may be opportunity to recamber the ground to allow it to free drain along the footpath into the lake.

Alternatively provision of an aco-drain and pipe connection into existing drainage network or towards the lake.

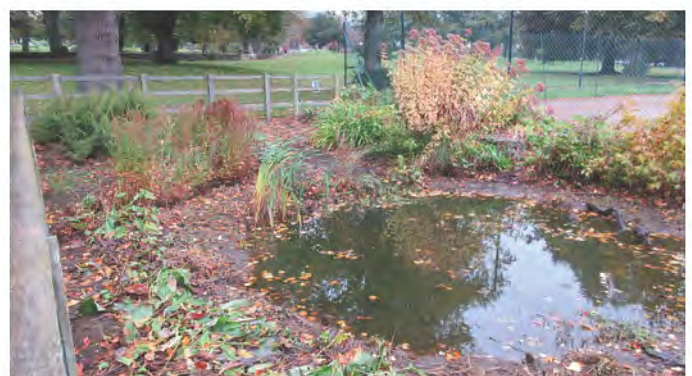
Further east there have been historical issues with rainwater coming off the high ground of the church and abbey zone causing flooding of the fenced play area in the valley. A fenced rain garden has been installed with a drain that channels the water from the main drive into

the rain garden. This has been effective in most low rainfall situations. However, during periods of high rainfall it often overflows and floods part of the play area.

Option 1: Connect the rain garden into Finham Brook by a series of swales with boardwalk crossings into the children's meadow. For example Hollickwood School swales:

Option 2: In addition, consider opportunities for additional rain gardens along the line of the play area to take rainwater run off from the higher ground. These could be introduced as part of the leisure centre development.

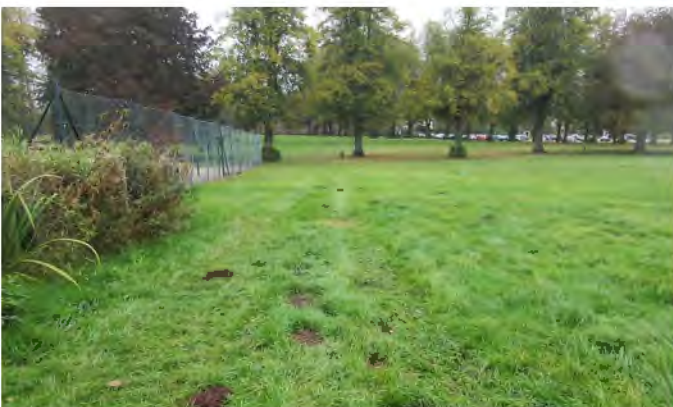
Wetter ground is noted to the east of the playground meadow boundary and also the tennis courts boundary. It is possible that this is caused by rainwater run off from the tennis courts and it is also a naturally low lying area where water collects. The ground is soft and appears difficult to mow at certain times of year, but there are no signs of marshland species. This area is used fully during events and is earthquake drained to keep it dry.

Due to the events that occur on this land, it is not practical to introduce swales and rain gardens to assist with the drainage of the tennis courts. It is considered that the tennis courts to continue to free drain onto existing green surfaces and that earthquake drainage to continue in this location for the purpose of events.

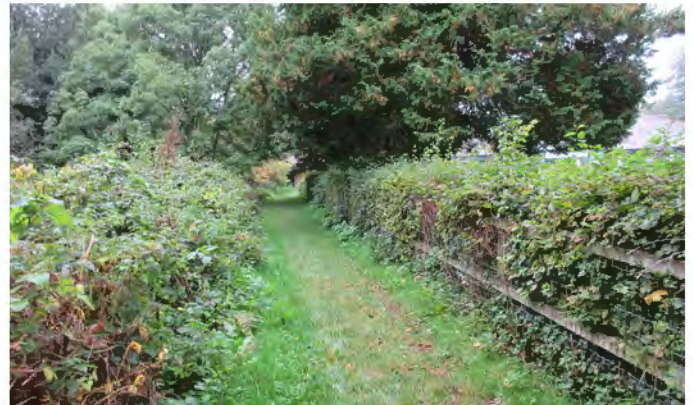
The informal path to the south of the play area is wet and boggy in places. This appears to be a well used path and looks to become muddy.

- 1. Retaining as an informal path may require some consideration for drainage channels into Finham Brook.**

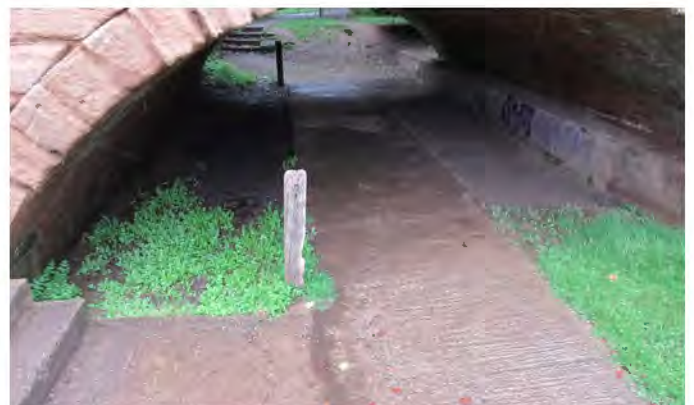
The underpass to Bridge Street, provides limited access under the bridge via steps and ramps. Water appears to collect and has led to boggy wet ground. There is a drain alongside the path under the bridge however it is located above the wettest area. This area is managed by Warwickshire County Council Highways.

1. **Regular removal of silt from the existing drains would assist with drainage in this location.**
2. **Consideration of stoning the areas either side of the concrete path to reduce the muddy surface under the bridge.**

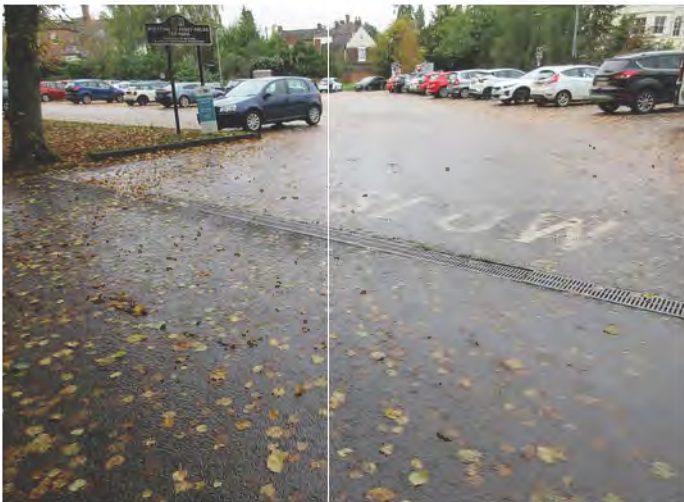
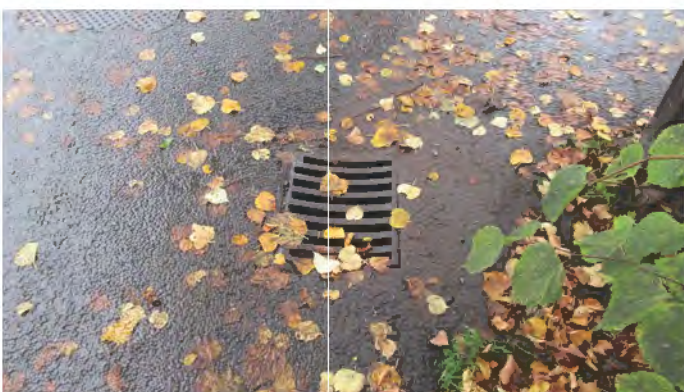
The car park is a large area of hard standing, which currently collects rainwater in a wide slot drain channel at the entrance as well as an additional gully drain located to the base of Church Walk.

However, these drainage points are known to overflow particularly in high rainfall and water collects at the entrance driveway causing soft spots and ruts to the entrance area where vehicles enter the Fields. This also continues along Main Drive to the Leisure Centre as water collects along the length, again causing ruts due to vehicles passing along the driveway.

Potential to create occasional passing places that also combine as water egress points, where water is encouraged to flow over these into the soft landscape beyond. Ensuring that the grass is graded below the level of the roadway, allows it to run off to the lower ground beyond and not collect on the hardstanding. Additionally provision of an area of long grass 1m from the edge of the hard standing would slow the flow and clean the water runoff.
